## INTOXILYZER® 8000: HOLE DRILLED – BREATH INSTRUMENT MODIFIED

Article Written By: Matthew E. Malhiot

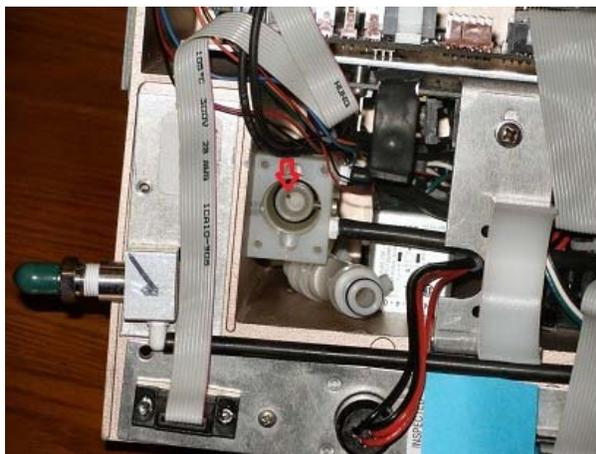
Troubleshooting procedures were immediately implemented; as we began checking the simulators for proper temperature and air tight seals. We also inspected the hoses and the connectors that were being used between the instrument and simulator. The connectors were changed many times using many different types of connectors, in an attempt to find the source of the problem. None of our troubleshooting efforts rectified or changed the low simulator results. Mr. William Schofield, CMI Inc.'s Chief Engineer at the time was consulted; upon which he recommended drilling a hole in the exhaust block check valve. Following Mr. Schofield's recommendation, a hole was drilled and the breath test instrument immediately began to produce simulator results within the target valve. Today, all Intoxilyzer® 8000s used throughout the State of Florida have the same hole drilled in the exhaust block check valve.

The exhaust block check valve inside the Intoxilyzer® 8000 is called a passive valve system and is designed so that air flow will follow the path of least resistance. This type of valve system has the potential to cause "purge fail" problems, as well as many other problems experienced with the Intoxilyzer® 8000s used in many different states.
